A Multidisciplinary Approach for Restoring Function and Esthetics in a Patient with Worn out Dentition: a Clinical Report

CASE REPORT

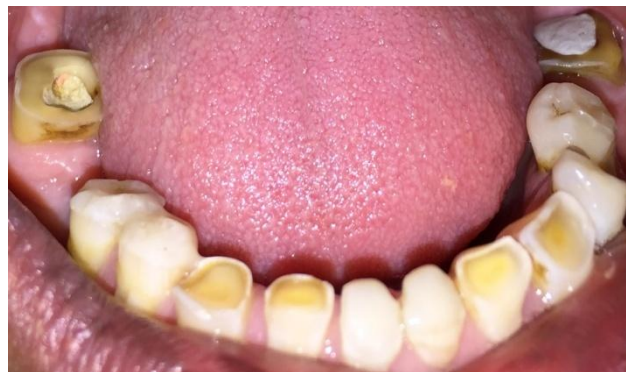
A 38-year-old male patient presented to the Department of endodontics of the I.T.S. Dental College & Research Institute in muradnagar, ghaziabad, India, with severe attrition and abrasion of all of his teeth. He was very self-conscious about his appearance. A detailed history revealed patient had the habit of bruxism and brushing his teeth vigorously with hard bristle tooth brush. Extra oral examination revealed an unaesthetic smile. The intraoral examination (Fig. 1) revealed a Class I malocclusion with the surfaces of the teeth were rough with the enamel either not visible or very thin and hypoplastic over the crowns of all teeth and yellow-brown in color. The dentin, where it was exposed, was brown and hypersensitive. The patient had all the permanent teeth erupted including third molars. Tooth 36 was completely decayed with total loss of clinical crown. Tooth 41 had Miller's Grade II gingival recession^[8] with marginal gingiva extending upto mucogingival junction. The panoramic radiograph revealed that the teeth had normal pulpal morphology while the enamel appeared to be very thin or missing on all the teeth.

Fig. 1: Pre-treatment intra-oral photographs

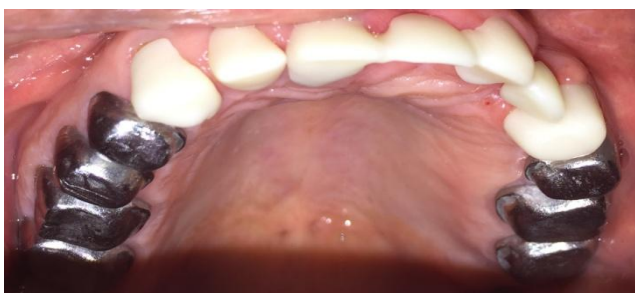
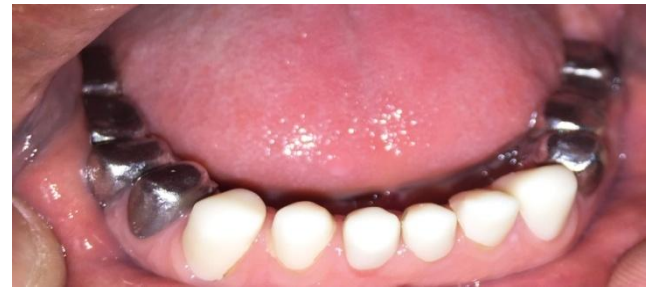
Fig. 2: Copings in place

articulator (Hanau™ Wide-View Arcon Articulator, Waterpik, Fort Collins, USA). A diagnostic wax up was done and the articulator was set for condylar and incisal guidance. Later, preparations of all the teeth were done to receive metal-ceramic restorations. Impressions were taken using polyvinyl-siloxane impression material (ReprosilR; Dentsply Caulk, Dentsply International Inc.) using custom trays and interocclusal relationships were recorded. The vertical dimension was increased by 3 mm in the premolar region in order to restore a favorable occlusal relationship. All prepared teeth were restored with provisional crowns cemented with Provicol (Voco GmbH, Germany) . The occlusal records were transferred to a semi- adjustable articulator with a facebow, and the final casts were mounted. Keeping in mind less occlusal clearance in molar region, it was decided to fabricate cast crowns for mandibular right and left 2nd and 3rd molars. Metal frameworks were fabricated and were evaluated intraorally to determine the marginal fit, followed by the ceramic firing. Prior to glazing of the ceramic material a trial insertion was performed, again to enable final occlusal refinement. The patient's natural occlusal scheme (canine-protected occlusion) and anterior guidance were preserved in the definitive restorations to decrease lateral forces on the posterior dentition. The crowns were then completed in the laboratory and cemented with glass ionomer cement (GC, luting & lining cement, GC Corporation, Tokyo, Japan) (Fig. 4). The anterior and posterior metal-ceramic crowns were satisfactory both esthetically and functionally. The patient was highly satisfied with the treatment results.

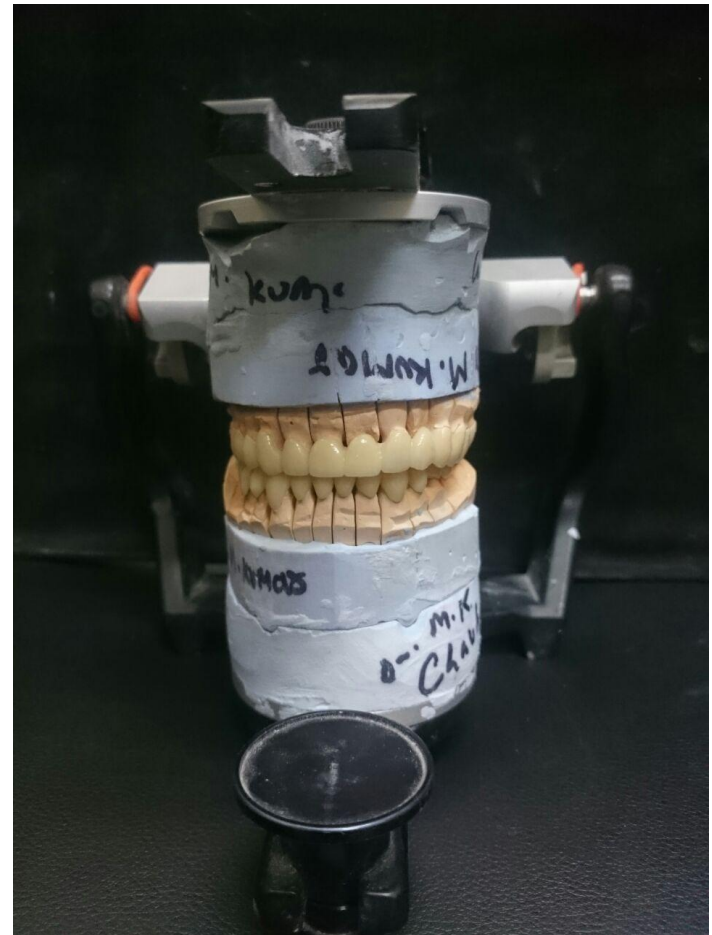
Fig. 3: Ceramic Build up on articulator

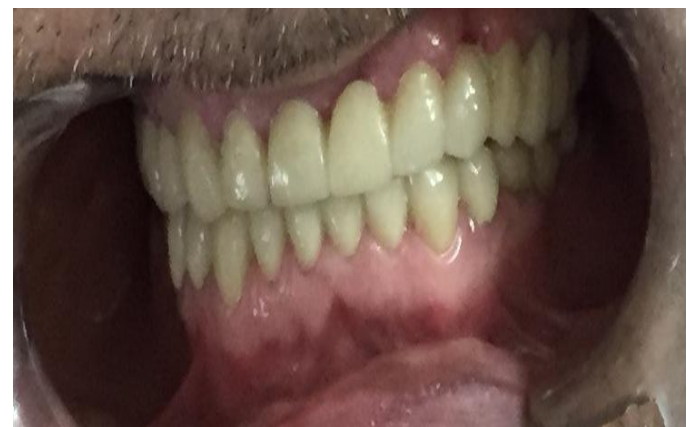
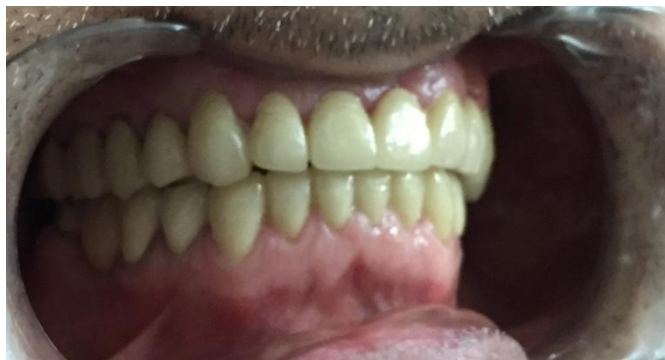
Fig. 4: Post treatment intra-oral photographs
